## Release Notes for DrayTek Vigor2862 series (UK/Ireland)

Firmware Version	3.9.0_BT (Formal Release)
Release Type	<b>Regular</b> – Upgrade recommended when convenient
Build Date	30 <sup>th</sup> November 2018
Release Date	2 <sup>nd</sup> January 2019
Revision	78129
Applicable Models	Vigor2862, Vigor2862n, Vigor 2862Ln, Vigor2862ac, Vigor 2862Lac, Vigor 2862Vac
VDSL Modem Code	779517
ADSL Modem Code	773F01
Locale	UK & Ireland Only

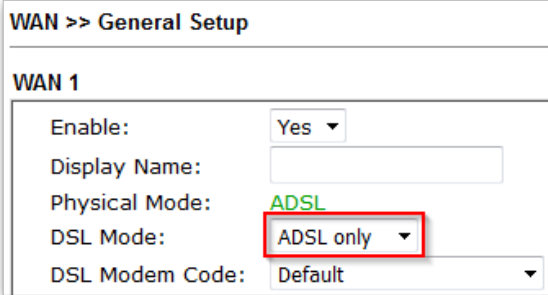
1. If experiencing an issue establishing an Internet connection on ADSL or ADSL2+ connections, set the WAN1 DSL Mode to “ADSL Only”
