Release Notes for DrayTek Vigor2862 series (UK/Ireland)

Firmware Version	3.9.6.1_BT (Formal Release)
Release Type	Regular – Upgrade recommended when convenient
Build Date	01 st April 2021
Release Date	04 th May 2021
Revision	6249_557_d35775af3
Applicable Models	Vigor2862, Vigor2862n, Vigor 2862Ln, Vigor2862ac, Vigor 2862Lac, Vigor 2862Vac
VDSL Modem Code	779517
ADSL Modem Code	773F01
Locale	UK & Ireland Only

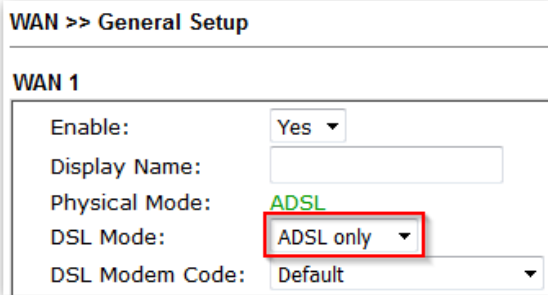
1. If experiencing an issue establishing an Internet connection on ADSL or ADSL2+ connections, set the WAN1 DSL Mode to “ADSL Only”
