## **Release Notes for DrayTek Vigor2862 series (UK/Ireland)**

Firmware Version	3.9.8.1_BT (Formal Release)
Release Type	<b>Regular</b> – Upgrade recommended when convenient
Build Date	26 <sup>th</sup> April 2022
Release Date	06 <sup>th</sup> May 2022
Revision	12433_959_e14180a37
Applicable Models	Vigor2862, Vigor2862n, Vigor 2862Ln, Vigor2862ac, Vigor 2862Lac, Vigor 2862Vac
VDSL Modem Code	779517
ADSL Modem Code	773F01
Locale	UK & Ireland Only

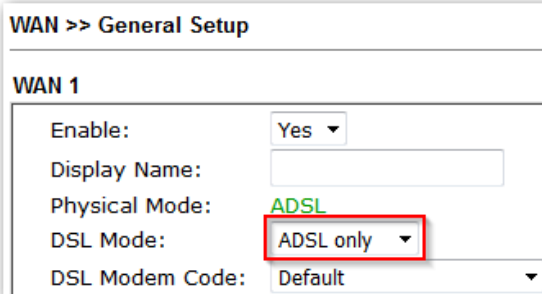
1. If experiencing an issue establishing an Internet connection on ADSL or ADSL2+ connections, set the WAN1 DSL Mode to “ADSL Only”
