Release Notes for DrayTek Vigor2862 series (UK/Ireland)

Firmware Version	3.9.9.8 (Formal Release)
Release Type	Critical – Upgrade recommended immediately
Build Date	21 st October 2024
Release Date	26 th November 2024
Revision	21908_1197_974fed38cc
Applicable Models	Vigor2862, Vigor2862n, Vigor 2862Ln, Vigor2862ac, Vigor 2862Lac, Vigor 2862Vac
VDSL Modem Code	779517
ADSL Modem Code	773F01
Locale	UK & Ireland Only

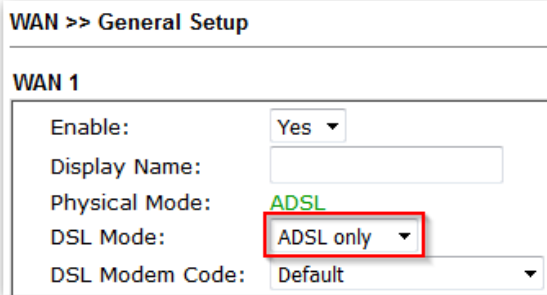
1. If experiencing an issue establishing an Internet connection on ADSL or ADSL2+ connections, set the WAN1 DSL Mode to “ADSL Only”
