Release Notes for DrayTek Vigor 120 v2 (UK/Ireland)

Firmware Version	3.2.8.2 (Formal Release)
Release Type	Regular – Upgrade recommended when convenient Note: A previous firmware (3.2.8.1) was a critical release . This f/w includes all changes/improvements that were in 3.2.8.1.
Build Date	10 th April 2017
Release Date	24 th April 2017
Revision	63056
Applicable Models	Vigor 120 v2
ADSL Modem Code	332201 Annex A
Locale	UK & Ireland Only

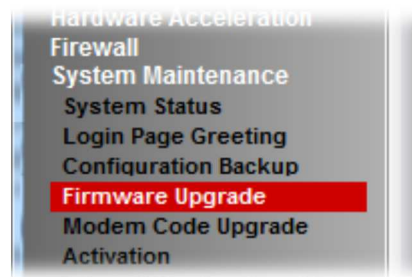
To upgrade firmware, select '*firmware upgrade*' from the modem's system maintenance menu and select the correct file. Ensure that you select the ALL file unless you want to wipe out your modem's settings back to factory default.
