Release Notes for DrayTek Vigor2762 series (UK/Ireland)

Firmware Version	3.9.0_BT (Formal Release)
Release Type	Regular – Upgrade recommended when convenient
Build Date	26 th December 2018
Release Date	22 nd January 2019
Revision	78873
Applicable Models	Vigor2762, Vigor2762n, Vigor2762ac, Vigor 2762Vac
VDSL Modem Code	779517
ADSL Modem Code	773F01
Locale	UK & Ireland Only

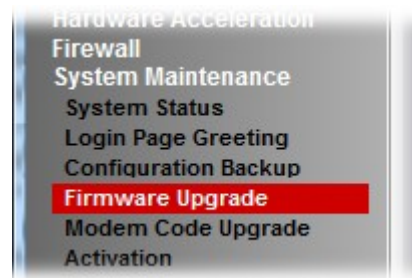
To upgrade firmware, select '*firmware upgrade*' from the router's system maintenance menu and select the correct file. Ensure that you select the ALL file unless you want to wipe out your router's settings back to factory default.
