Release Notes for DrayTek Vigor2860 series (UK/Ireland)

Firmware Version	3.8.4.5_BT (Formal Release)
Release Type	Regular – Upgrade recommended when convenient
Build Date	12 th May 2017
Release Date	2 nd June 2017
Revision	65131
Applicable Models	Vigor2860, Vigor2860n, Vigor2860Vn, Vigor 2860n+, Vigor 2860Vn+ Vigor 2860ac, Vigor 2860Vac, Vigor 2860L, Vigor 2860Ln
Locale	UK & Ireland Only

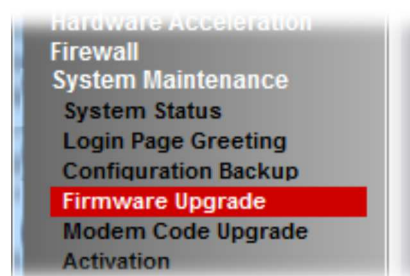
To upgrade firmware, select '*firmware upgrade*' from the router's system maintenance menu and select the correct file. Ensure that you select the ALL file unless you want to wipe out your router's settings back to factory default.

It is recommended that you take a configuration backup prior to upgrading the firmware. This can be done from the router's system maintenance menu.
