Release Notes for DrayTek Vigor 2926 series (UK/Ireland)

Firmware Version	3.9.1.1 (Formal Release)
Release Type	Regular – Upgrade recommended when convenient
Build Date	19 th August 2019
Release Date	9 th September 2019
Revision	84162
Applicable Models	Vigor2926, Vigor2926n, Vigor2926ac
Locale	UK & Ireland Only

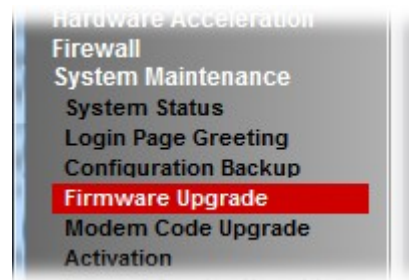
To upgrade firmware, select '*firmware upgrade*' from the router's system maintenance menu and select the correct file. Ensure that you select the ALL file unless you want to wipe out your router's settings back to factory default.
