Release Notes for DrayTek Vigor 2926 series (UK/Ireland)

Firmware Version	3.9.3.1 (Formal Release)
Release Type	Regular – Upgrade recommended when convenient
Build Date	6 th April 2020
Release Date	16 th April 2020
Revision	89435
Applicable Models	Vigor2926, Vigor2926n, Vigor2926ac
Locale	UK & Ireland Only

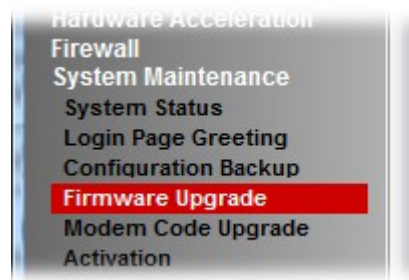
To upgrade firmware, select '*firmware upgrade*' from the router's system maintenance menu and select the correct file. Ensure that you select the ALL file unless you want to wipe out your router's settings back to factory default.
