## Release Notes for DrayTek Vigor 2926 series (UK/Ireland)

Firmware Version	3.9.3 (Formal Release)
Release Type	<b>Regular</b> – Upgrade recommended when convenient
Build Date	25 <sup>th</sup> February 2020
Release Date	23 <sup>rd</sup> March 2020
Revision	88735
Applicable Models	Vigor2926, Vigor2926n, Vigor2926ac
Locale	UK & Ireland Only

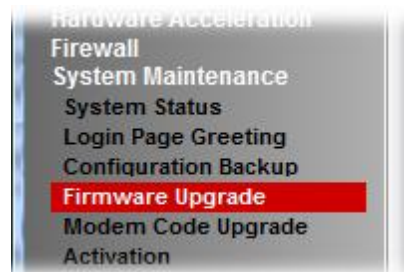
To upgrade firmware, select '*firmware upgrade*' from the router's system maintenance menu and select the correct file. Ensure that you select the ALL file unless you want to wipe out your router's settings back to factory default.
