Release Notes for DrayTek Vigor 2926 series (UK/Ireland)

Firmware Version	3.9.9.7 (Formal Release)
Release Type	Critical – Upgrade recommended immediately
Build Date	12 th September 2024
Release Date	18 th October 2024
Revision	21607_1189_918fff549c
Applicable Models	Vigor2926, Vigor2926n, Vigor2926ac
Locale	UK & Ireland Only

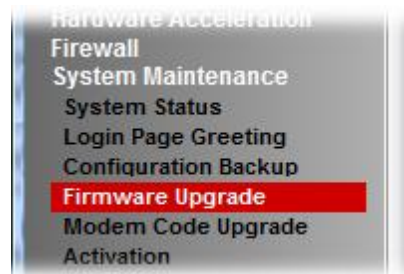
To upgrade firmware, select '*firmware upgrade*' from the router's system maintenance menu and select the correct file. Ensure that you select the ALL file unless you want to wipe out your router's settings back to factory default.
