## Release Notes for DrayTek Vigor 3912 (UK/Ireland)

Firmware Version	4.3.6.1 (Formal Release)
Release Type	<b>Regular</b> – Upgrade recommended when convenient
Build Date	23 <sup>rd</sup> July 2024
Release Date	13 <sup>th</sup> August 2024
Revision	4188_5045_109e0bd
Applicable Models	Vigor 3912, Vigor 3912S
Locale	UK & Ireland Only

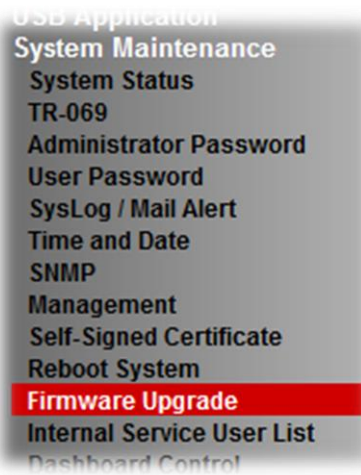
To upgrade firmware, select '*firmware upgrade*' from the router's system maintenance menu and select the correct file. Ensure that you select the SFW file unless you want to wipe out your router's settings back to factory default.

It is recommended that you take a configuration backup prior to upgrading the firmware. This can be done from the router's system maintenance menu.
