Release Notes for DrayTek VigorBX 2000 series (UK/Ireland)

Firmware Version	3.9.1
Release Type	Regular – Upgrade recommended when convenient
Release Date	27 th January 2020
Build Date	27 th December 2019
Revision	87539
Applicable Models	VigorBX 2000, VigorBX 2000n, VigorBX 2000ac
Locale	UK Only / Annex A Only

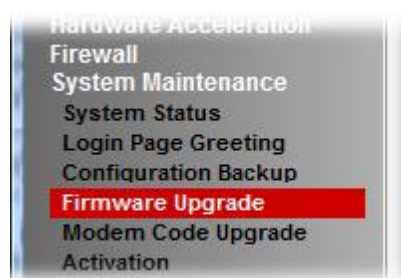
To upgrade firmware, select '*firmware upgrade*' from the router's system maintenance menu and select the correct file. Ensure that you select the ALL file unless you want to wipe out your router's settings back to factory default.
